Enhancing Sewer Asset Reliability Through Innovative Stabilised No- Entry Visual Inspection Technology

James Shingles
Ozwater'26

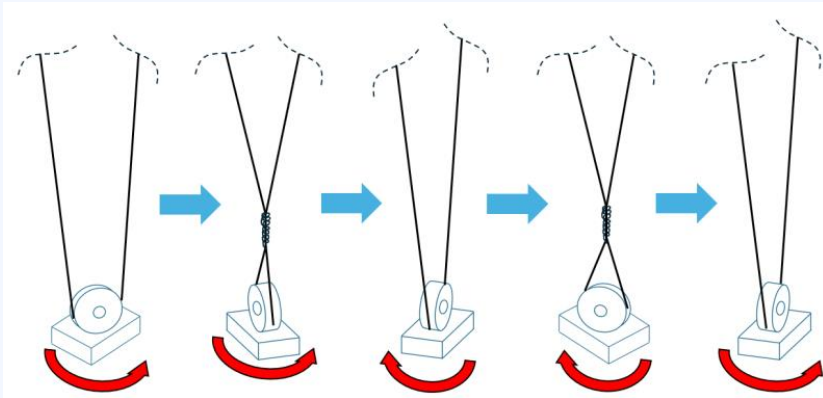
Original Device Runaway Effect

- Rope and Pulley design
- Shakey footage at lower depths
- Uncontrolled spinning – Runaway effect

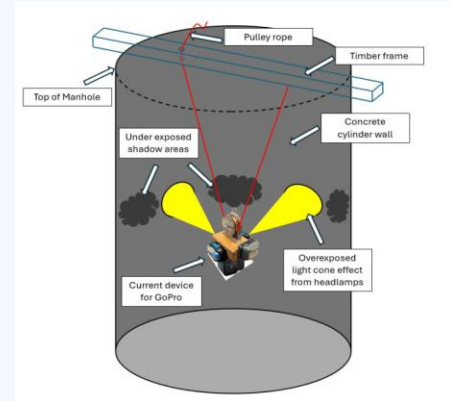
Original Device Spotlighting

- 4 x headlamps
- High intensity spotlights
- Under exposed areas

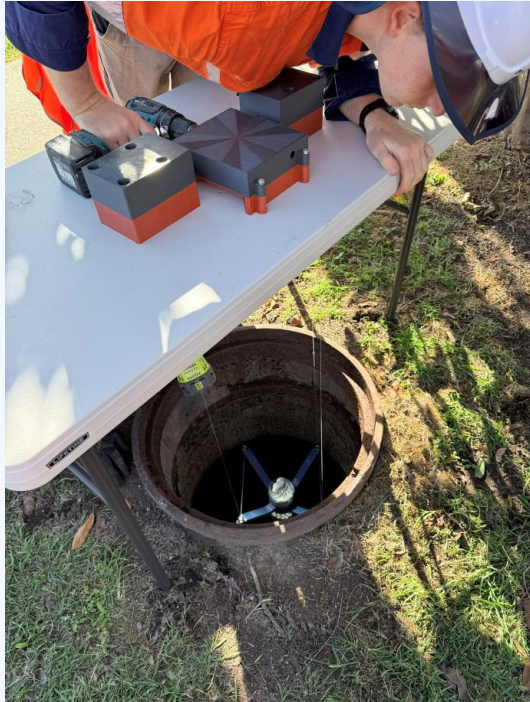
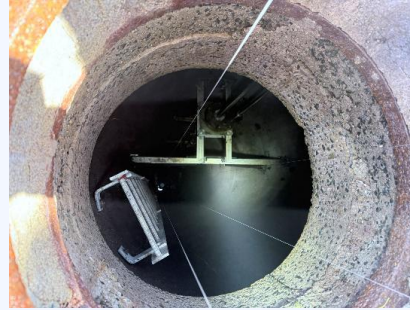
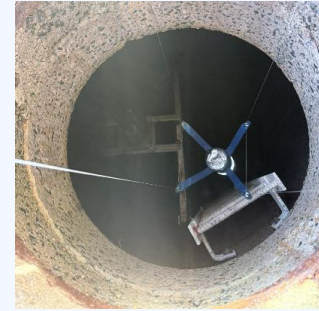
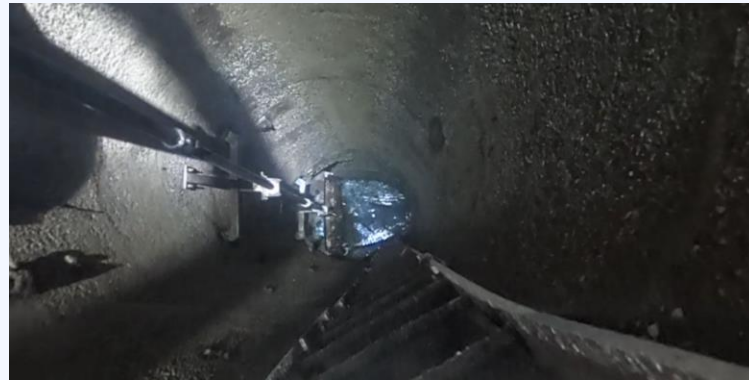
Field Test – 19m Manhole

Cover Frame Corrosion

Penstock Operating Gearbox

Manhole Ladder

Corrosion on MH Cover frame

Ladder good (top section) First 30 rungs

Ladder poor (lower section) Corrosion and accumulation of rags/sludge observed

Penstock poor condition Rusting and accumulation of rags/sludge observed

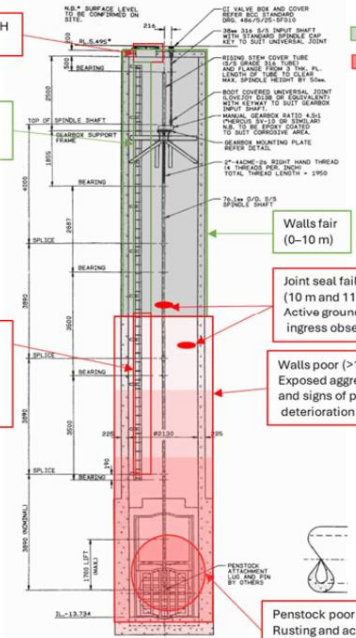
Inspection Results Annotated Drawing

Walls fair (0-10 m)

Joint seal failure (10 m and 11 m) Active groundwater ingress observed

Walls poor (>10 m) Exposed aggregates and signs of progressive deterioration

Good Condition
Poor Condition

Concrete Wall Leaking

Eroded Manhole Wall

Sewer Door Penstock
