# Replacement of Damaged Bridge Barriers at Pimpama Bridge: A Risk Based Approach

## Abstract

In the evening of November 2024, a truck collided with the westbound barrier of the Pimpama Bridge. The barrier was unable to contain the vehicle, with the final position of the truck vertical in the creek below. Thankfully, there were no fatalities.

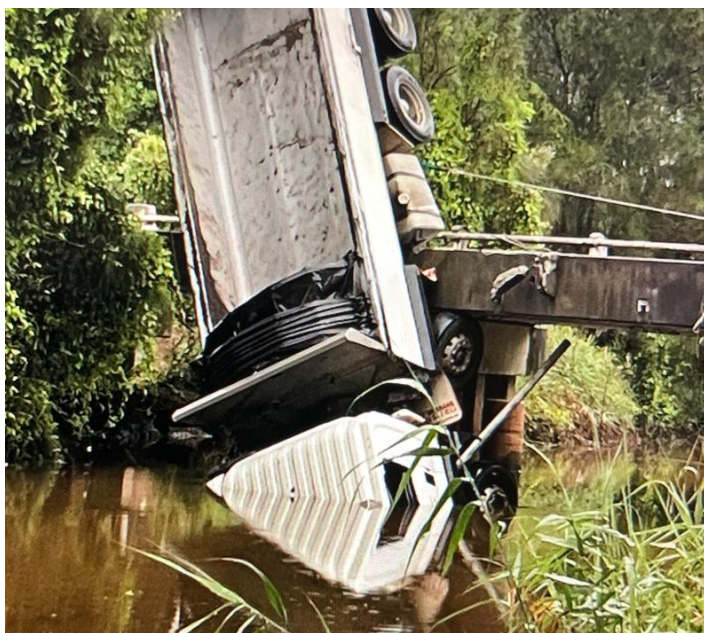
**Figure 2.** Bridge site immediately after accident

On 18 November 2024 at approximately 11:43 pm a rigid body truck collided with the westbound bridge barrier which was unable to contain the vehicle (Figure 3). There were no fatalities or serious injuries, and the cause of the incident is understood to be under investigation.

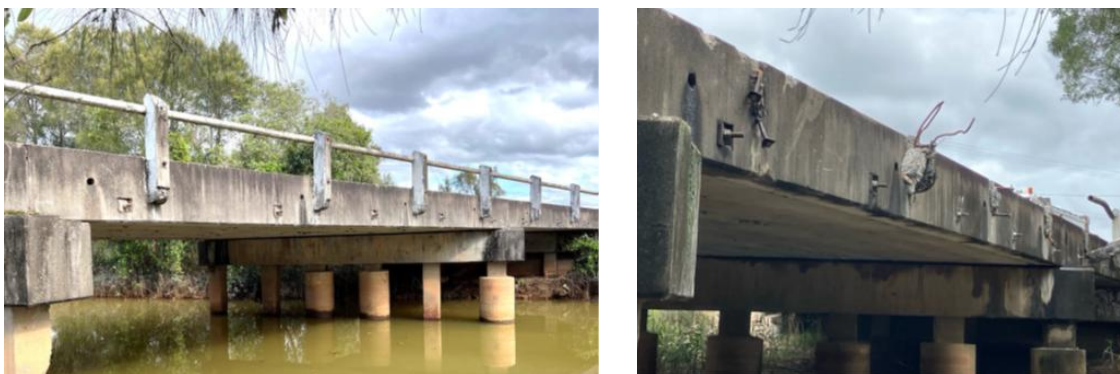
**Figure 3.** Left, Bridge barrier before the accident, Right, Bridge barrier

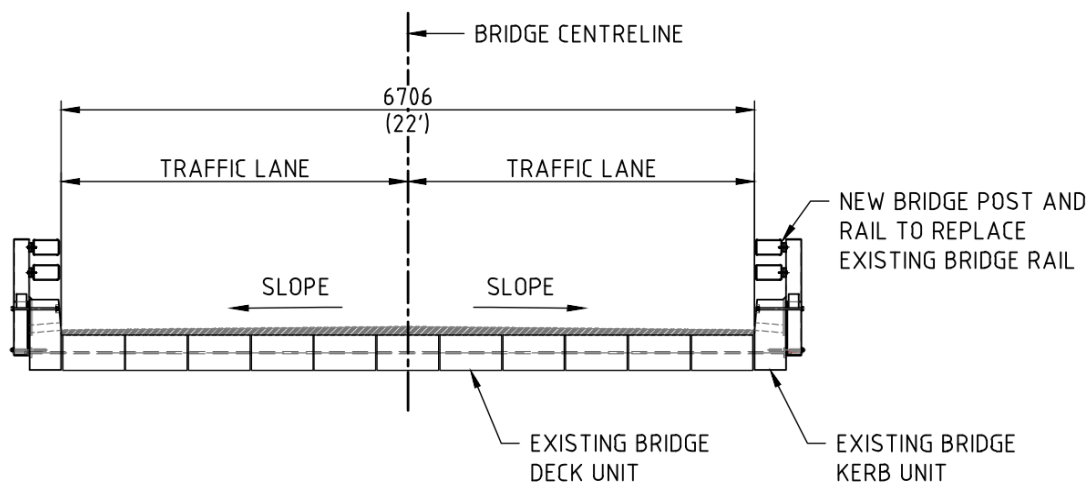
**Figure 6.** Post and rail configuration

Two parallel 250 x 150 RHS rails were adopted to comply with AS 5100.1 Cl 14.6.2, ensuring the clear opening between rails is less than 380 mm and that the front face of the rails is within 25 mm of the concrete kerb vertical face.

For the posts, 150 SHS members were chosen to provide a uniform visual outcome with other bridges on the network. 150 SHS posts are of similar geometry to the existing bridge posts and are aligned with the post sizes shown in TMR Std Drg 2200 "Post and Rail Traffic Barriers – Regular Performance".

Where possible, connections and detailing followed TMR Std Drg 2200 to provide a standardised outcome consistent with other structures on the network (Figure 6).

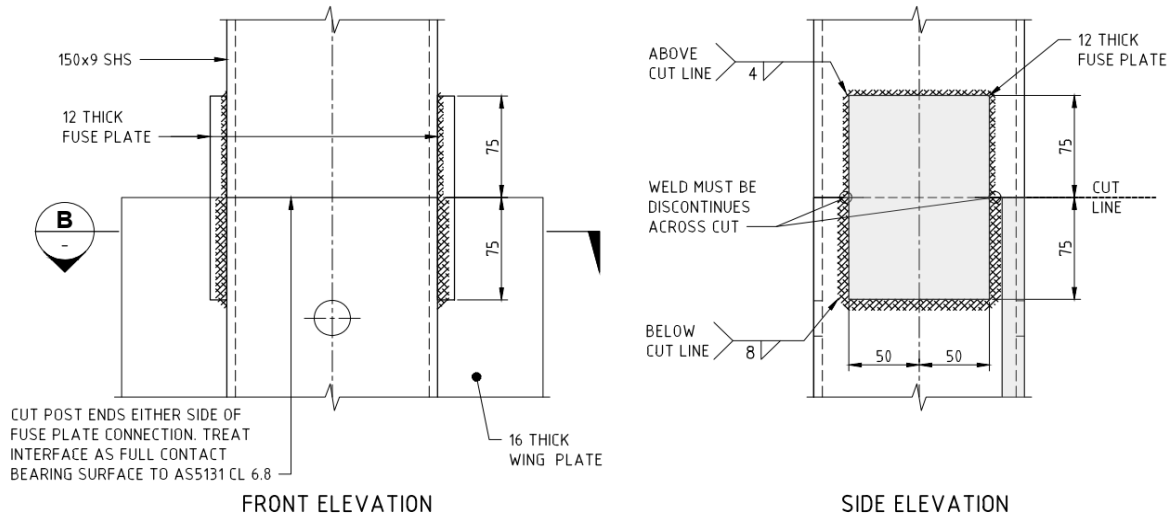
The existing bridge kerb capacity is the limiting factor for the new barrier design. The section size chosen for the posts was driven by geometric reasons and is inherently greater than the capacity of the kerb unit.

**Figure 7.** Fuse connection detail

In the event of a future vehicle collision, it is significantly more time and cost effective to replace steel bridge barriers than it is to undertake remediation of primary structural members such as kerb units. On this basis, the barrier posts were designed with a fuse connection to ensure the barrier fails before the kerb unit (Figure 7).

The fuse connection developed for Pimpama Jacobs Well Road bridge No. 1 was designed to fail along the weld line. The fuse connection weld size and length iteratively refined to achieve the low performance vehicle impact resistance. The connection was designed using hand calculations and verified independent using Strand7 FEA and IDEA StatiCa FEA models (Figure 8 & Figure 9).

The anchor bolt tension force under this load case was 52 kN representing 59% utilisation, indicating that the fuse connection will be the point of failure in the event of a vehicle impact.

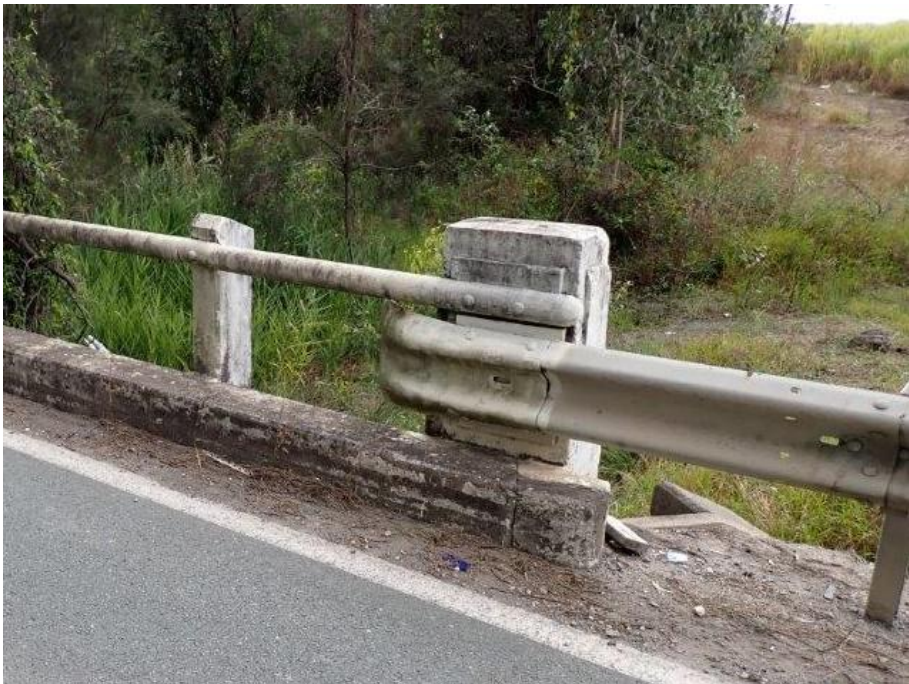
1. **Horizontal tie-in:** Existing W-beam located with an offset from the horizontal plane of the kerb. The offset varied at each of the four end points from 103 mm to 183 mm (Figure 10). This is a hazard for vehicles that are in contact with the existing road barrier during a collision. The vehicle is directed into the bridge kerb instead of being directed along the front of the bridge kerb.
2. **Vertical tie-in:** W-beam approach barriers, particularly on the southern side of the bridge were measured from survey as 490–500 mm above FSL at the edge of the pavement, ~250 mm lower than the minimum required height of 787 mm.

**Figure 10.** Typical existing approach barrier to bridge connection

The options assessment identified the preferred outcome to be installing a guardrail transition segment between existing guardrail and bridge barrier. This outcome was chosen as an interim guardrail solution to allow barrier replacement works to occur now and allow CGC to complete a full upgrade to the approaches as part of future works.

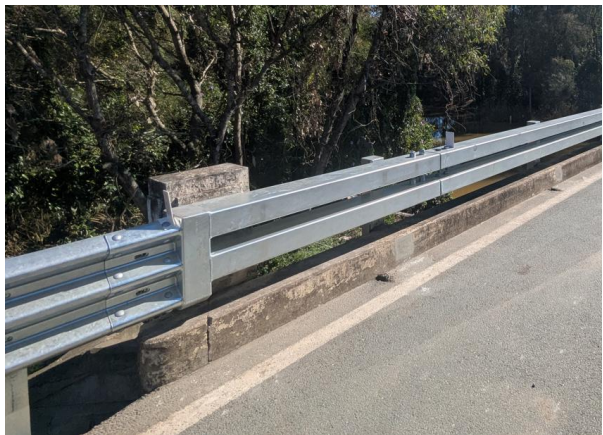
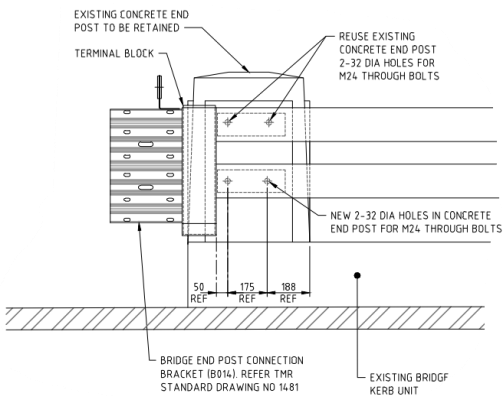
**Figure 11.** Installed guardrail transition in end post

The bridge barriers were designed to accommodate the guardrail transition and were connected to the existing concrete end posts using the existing barrier bolts holes for the new barrier top rail. Two new holes were drilled for the bottom rail, and to allow flexibility in construction tolerances, the new barrier rail holes were tapped on-site (Figure 11).

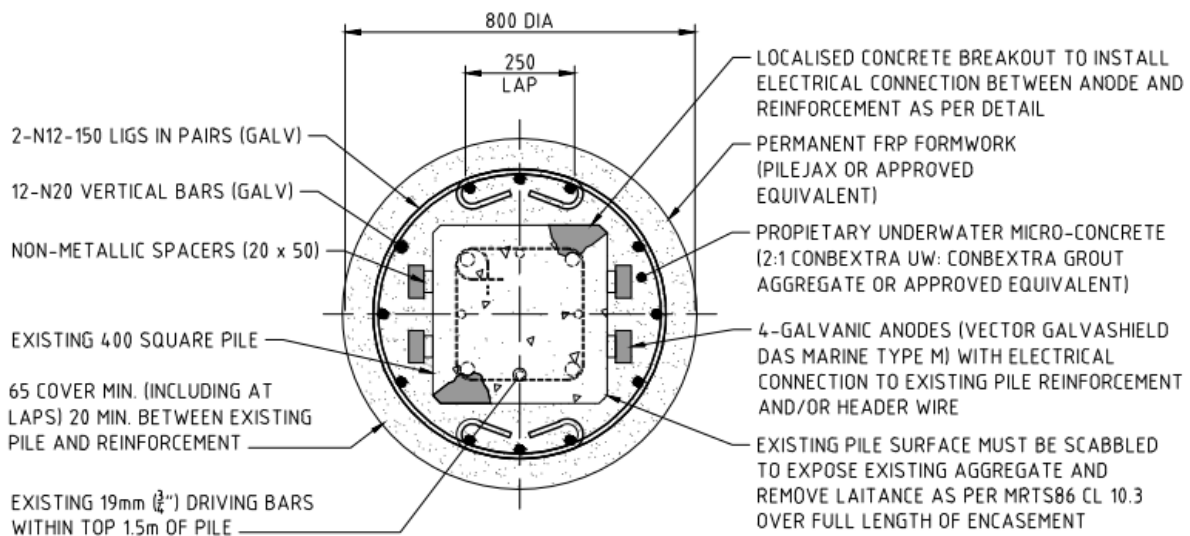
It was identified the bridge relies on the piles to resist lateral vehicle forces imposed by impact to the replacement bridge barriers. For this reason, rectification of the 4 un-encased piles was included in the project.

**Figure 12.** Pile encasement design section

- Removing all unsound concrete.
- Augmenting (i.e. lap welding) existing reinforcement where >20% cross section loss has occurred.
- Providing cathodic protection to the existing pile reinforcement.
- Constructing a reinforced concrete encasement with a permanent formwork system.

The encasement was designed as a non-structural element, providing durability protection to the cathodic protection anodes and existing pile. Reinforcement was provided for control of cracking and core confinement to AS 5100.5. Ligatures were detailed with hooks to facilitate installation sequencing and were positioned away from the cathodic protection anodes to ensure clearance for micro-concrete compaction (Figure 12).

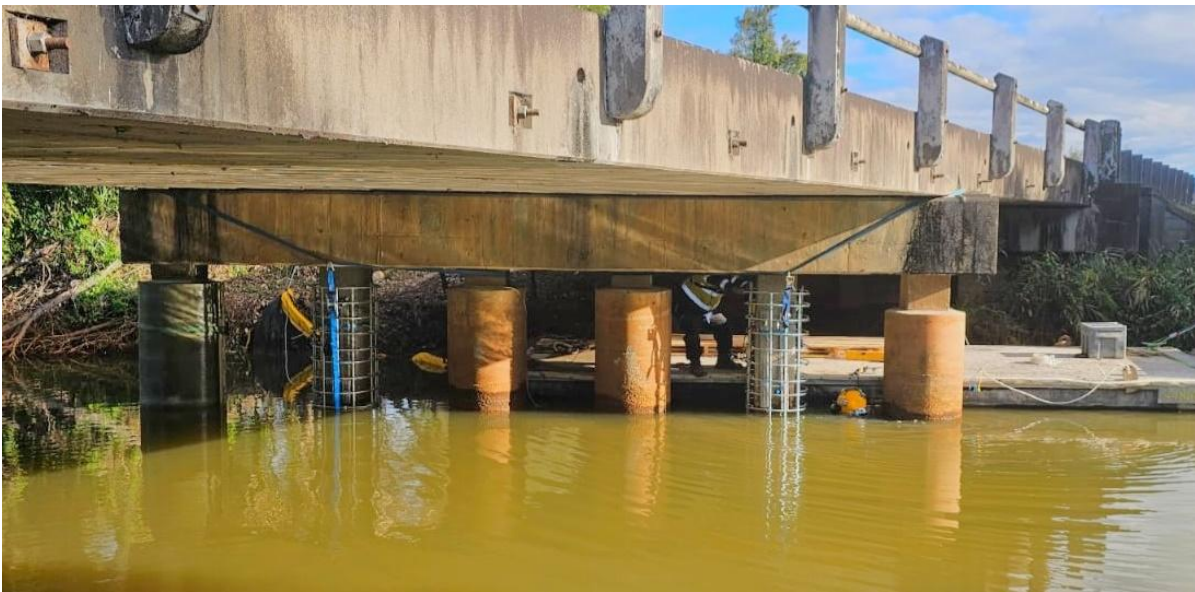
**Figure 14.** Pile encasement installation in progress

- A permanent formwork system (jackets) was nominated, with several suitable options provided depending on Contractor / CGC preference and lead times.
- The extent of encasement was nominated at ~100–200 mm below the existing bed level. These levels were chosen to minimise excessive excavation of the existing bed.

A proprietary underwater micro-concrete (Fosroc Conbextra UW / Conbextra Grout aggregate @ 2:1 ratio) was nominated to fill the annulus between the existing pile and permanent formwork. Discussions with the product supplier resulted in the inclusion of aggregate in the grout to manage the risk of excessive heat and shrinkage. The product supplier advised this blended product is readily pumpable and the properties are largely unchanged, and compatibility with the nominated galvanic anodes was maintained.

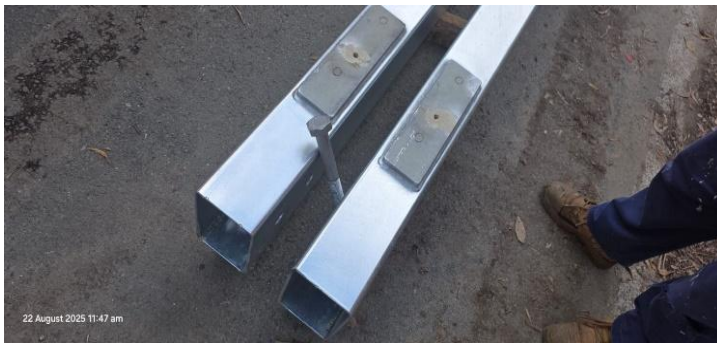
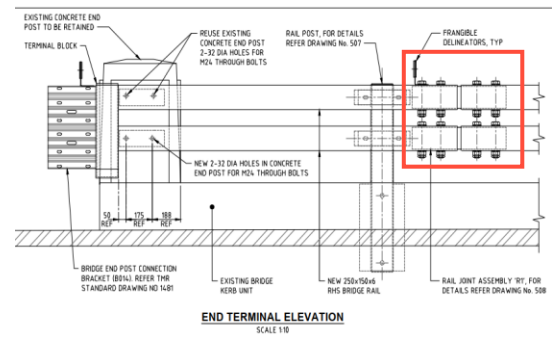
A constructability issue was uncovered only after the barriers had been designed, shop drawings prepared, and components fabricated and delivered to site. The rail connector bolts at the rail joint assembly were unable to be installed at the end terminal, as it was fabricated as a single piece as there was inadequate space for the bolt to be installed (Figure 15). A simple solution of using a single long threaded rod with an appropriate nut arrangement was proposed by the Contractor, which proved to be a simple solution which met the design intent.

**Figure 15.** Bolt unable to be put through hole in barrier
