# Rehabilitation of a Heritage Arch Bridge in Castlemaine, Victoria

This paper discusses the engineering and construction works undertaken on a heritage arch bridge in Castlemaine Victoria that was originally constructed in 1862 as a masonry arch; and widened in 1895 with a mass concrete arch. This skewed bridge spans 11.9 [DA1.1][RP1.2]m over the Midland Highway and supports three rail tracks. Works included: waterproofing, strengthening, concrete lining, parapet stabilisation and temporary works design. The bridge is managed by V/Line and Victorian Goldfields Rail[DA2.1][RP2.2]; works were undertaken by McInnes construction; and engineering by SMEC.

Midland Highway Bridge is an 11.9 m single-span skewed masonry arch rail over road bridge managed by V/Line located at 124.714 km in the township of Castlemaine along the Sunbury to Bendigo line.

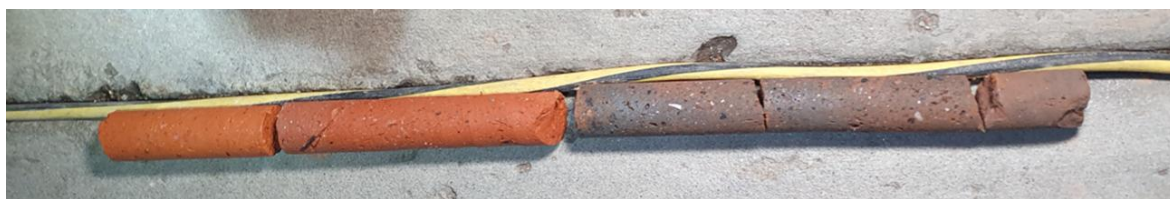
**Figure 2.** Core 4 through bridge abutment – ‘Void’ filled with mass concrete / grout (shown on the right-hand side)

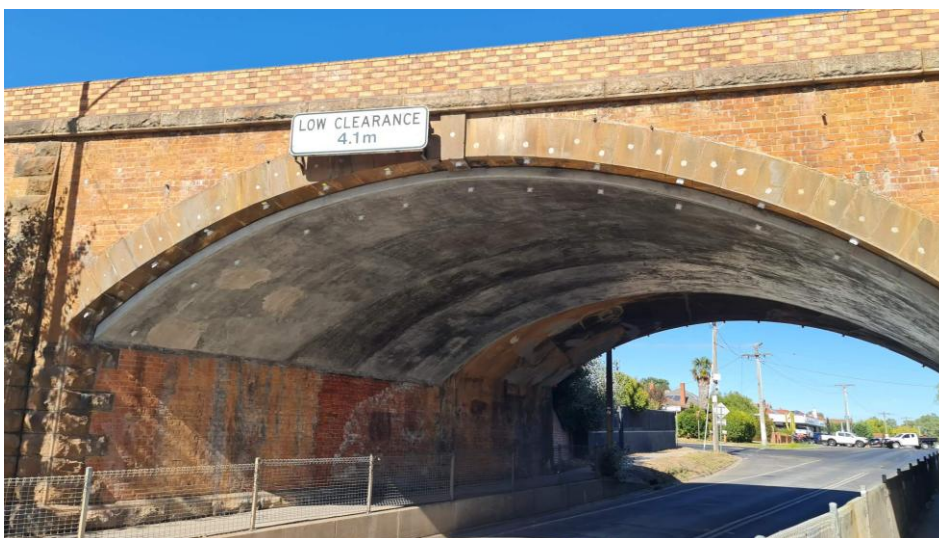
**Figure 9.** Completed soffit lining

- First mix design comprising the majority of the thickness of the arch lining that contained a concrete accelerator.
- Second, thinner, concrete spray that was applied after application of the main concreting; with the second layer able to be hand trowelled safely by site staff. An additional light reinforcement mesh, SL62, was included to enable the second mix to bind successfully while also minimizing the risk of shotcrete shadowing (i.e. if a heavier / denser second reinforcement mesh were used).

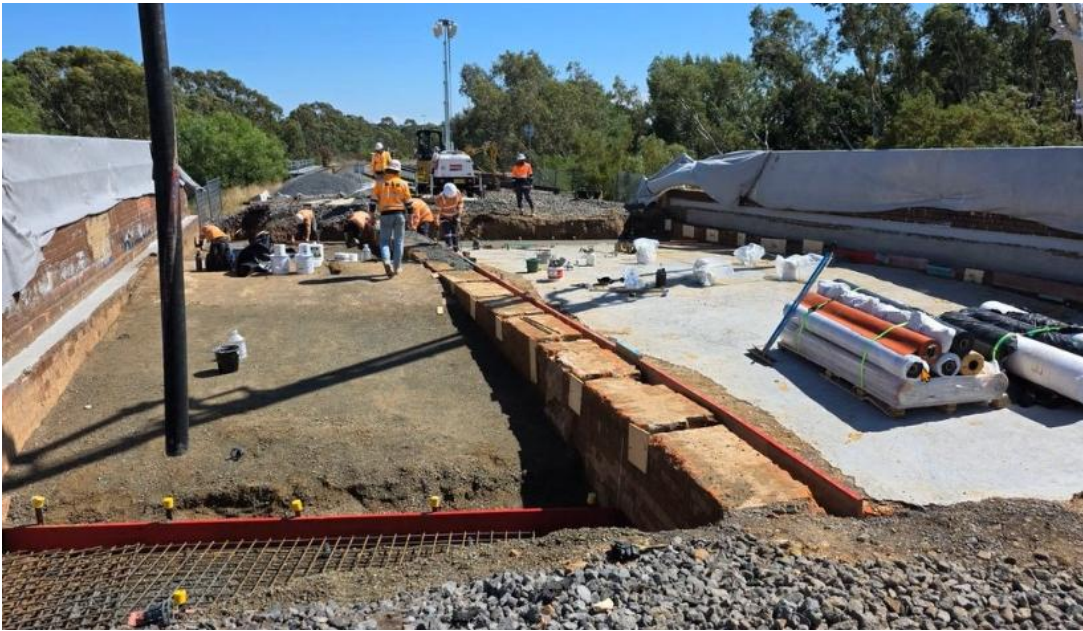
**Figure 10.** Waterproofing works – Looking down-track

The waterproofing system included the following layers:

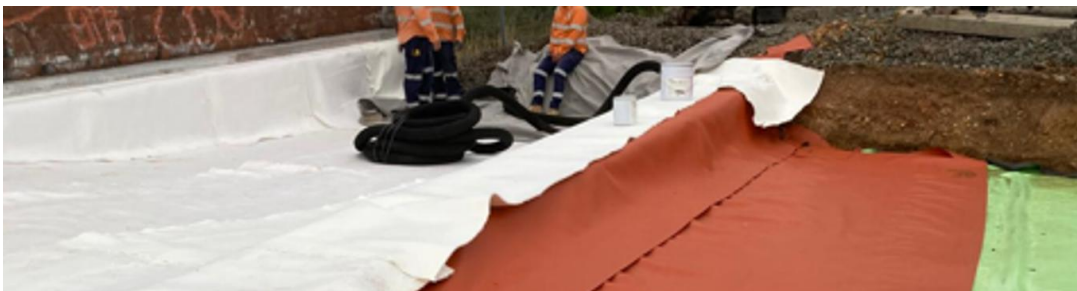
**Figure 11.** Waterproofing membrane and geofabric protection layer

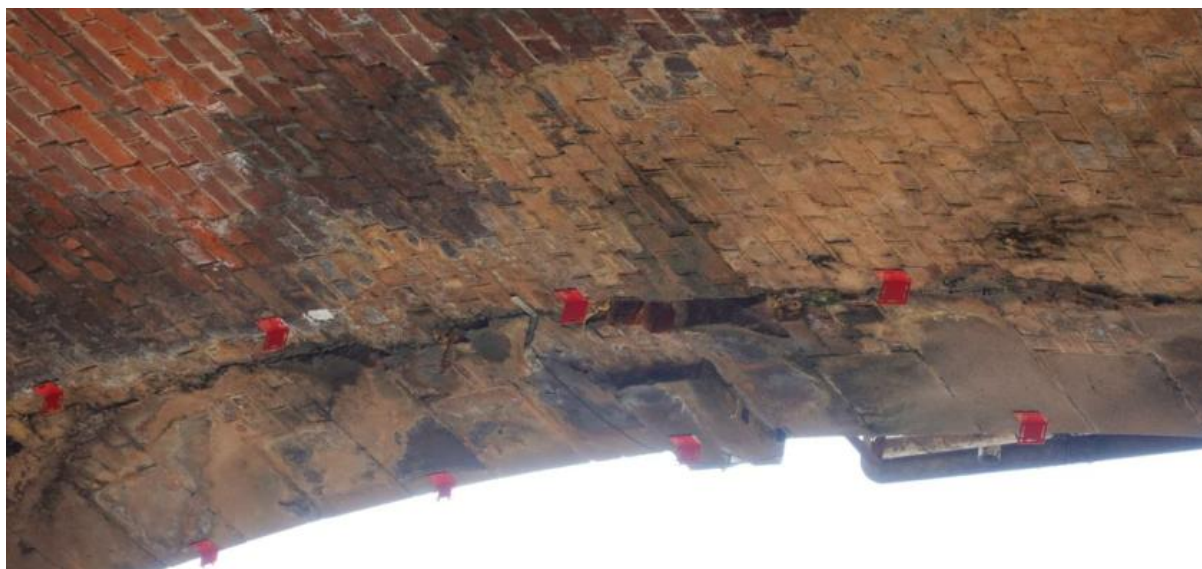
During inspection works, a longitudinal crack was observed between the existing spandrel wall and parapet for the masonry bridge arch barrel. Water was leaking through this joint at the crown of the arch.

**Figure 13.** Longitudinal crack between the spandrel wall and the arch barrel

The crack appeared wider at the top of the arch compared to closer to the abutments and therefore the spandrel wall may have been rotating about an axis parallel to rail traffic at datum closer to the springing line.

- Epoxy anchor into the arch barrel.
