# Replacement of Damaged Bridge Barriers at Pimpama Bridge: A Risk Based Approach

## Abstract

In the evening of November 2024, a truck collided with the westbound barrier of the Pimpama Bridge. The barrier was unable to contain the vehicle, with the final position of the truck vertical in the creek below. Thankfully, there were no fatalities.

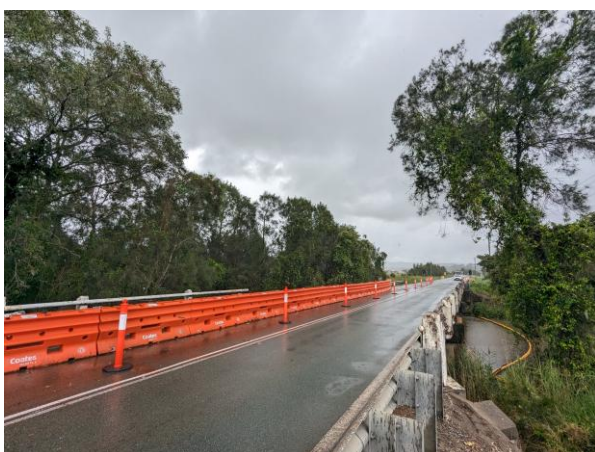
**Figure 4.** Temporary Traffic Control

The bridge was initially shut to all traffic immediately following the incident. Once the site was made safe and the vehicle had been removed, the road was reopened under temporary single lane traffic with stop/go traffic signals and water-filled barriers (Figure 4). This traffic arrangement would remain in place until September 2025.

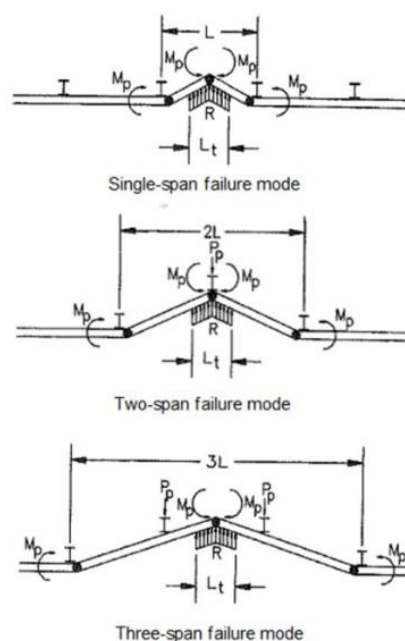
**Figure 5.** Possible failure modes for post and rail with failure of 1, 2 or 3 spans of posts (Source: Austroads AP-R445-13 Standardised Bridge Barrier Designs / AASHTO LRFD Bridge Design Specifications)

To assess the bridge performance under a regular performance impact load, a review of the likely structural capacity was undertaken. The critical failure case was found to be the existing kerb units for concrete cone failure induced by forces in the barrier bolt fixings.

Impact forces were applied to the barriers and distributed through the bridge rails into the posts in accordance with AS 5100.2 Clause 12.2.2 using the methodology described in Austroads AP-R445-13 Standardised Bridge Barrier Designs (Figure 5).

Resulting bolt tension forces were used to undertake a concrete cone failure assessment in accordance with AS 5100.5 Clause 14.3. The assessment concluded that:

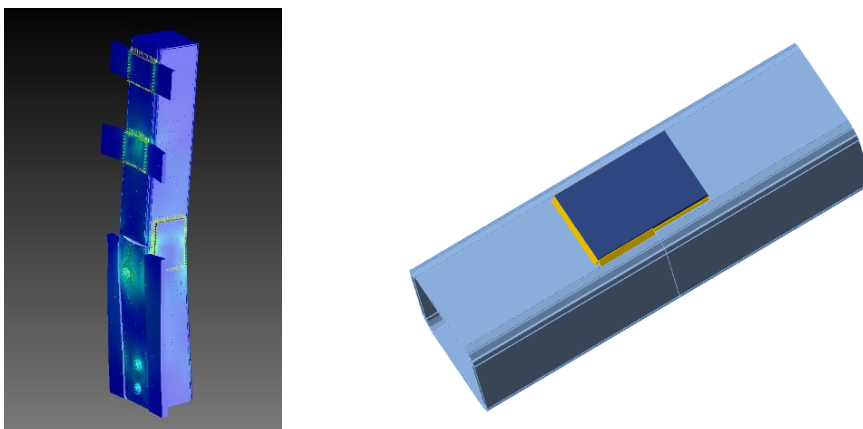
**Figure 8.** Left, Strand7 model of new barrier post, Right, IDEA StatiCa model of fuse connection in post

The fuse connection developed for Pimpama Jacobs Well Road bridge No. 1 was designed to fail along the weld line. The fuse connection weld size and length iteratively refined to achieve the low performance vehicle impact resistance. The connection was designed using hand calculations and verified independent using Strand7 FEA and IDEA StatiCa FEA models (Figure 8 & Figure 9).

The anchor bolt tension force under this load case was 52 kN representing 59% utilisation, indicating that the fuse connection will be the point of failure in the event of a vehicle impact.

In the event of a future vehicle collision, it is significantly more time and cost effective to replace steel bridge barriers than it is to undertake remediation of primary structural members such as kerb units. On this basis, the barrier posts were designed with a fuse connection to ensure the barrier fails before the kerb unit (Figure 7).

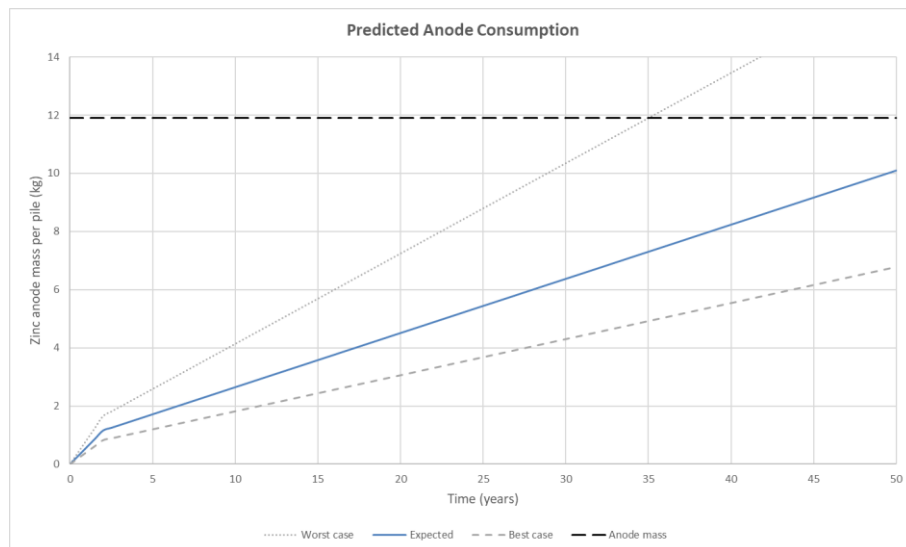
**Figure 13.** Galvanic anode consumption over design life

- Design life  $\geq 30$  years using a conservative initial current density of  $40 \text{ mA/m}^2$  and a maintenance current density of  $15 \text{ mA/m}^2$  (Figure 13).
- Highly turbid water made underwater diving works very difficult, hence electrical connection of anodes to existing reinforcement is only above water level. The anodes were interconnected below water level by a header wire.
- 2 electrical connections were nominated per pile, balancing redundancy and minimising damage to the existing pile. A conductor bar was included to avoid the need for reinforcement to be exposed for each anode connection location.
- The new galvanised reinforcement cage was intentionally electrically isolated from the original pile reinforcement to reduce the steel surface area to be protected by the anodes.

The nominated anodes (Vector Galvashield DAS Marine Type M) were specified due to their suitability for use in a tidal environment within concrete pile encasements.
