# Utilising point clouds to characterize defect sets in rock slopes

K. Stariha & H. Baxter-Crawford SMEC Australia Pty Ltd, Australia

**ABSTRACT:** As remote sensing technology has improved, advances have been made in using new forms of data to remotely undertake slope stability analysis. This is particularly useful where slopes may be difficult or unsafe to access. This paper outlines the processing and analysis of a point cloud collected at three outcrops adjacent to Bendora Dam which are no longer deemed safe to access. Analysis of the point cloud was undertaken to visualize existing defect sets and to characterize their orientation, spacing and waviness. An analysis of point normal orientation was undertaken to assess a directionally dependent dilation angle along exposed bedding surfaces.

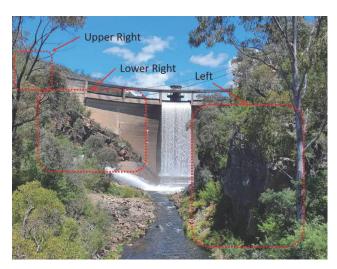
Fig. 1: Location of three outcrops under investigation.

As input to a 20-year Dam Safety Review, a remote sensing survey was taken of three rock outcrops, two on the right abutment, one on the left (Fig. 1). Whilst these outcrops were mapped traditionally by hand in the 1950's to the early 2000's, safety guidelines at Bendora Dam now mean that access to these abutments is only
